July Monthly Report for the Falls Creek Hydro-electric Project
FERC # P-11659

FALLS CREEK HYDROELECTRIC-PROJECT (P-11659)
MONTHLY CONSTRUCTION REPORT TO FERC
July 2006

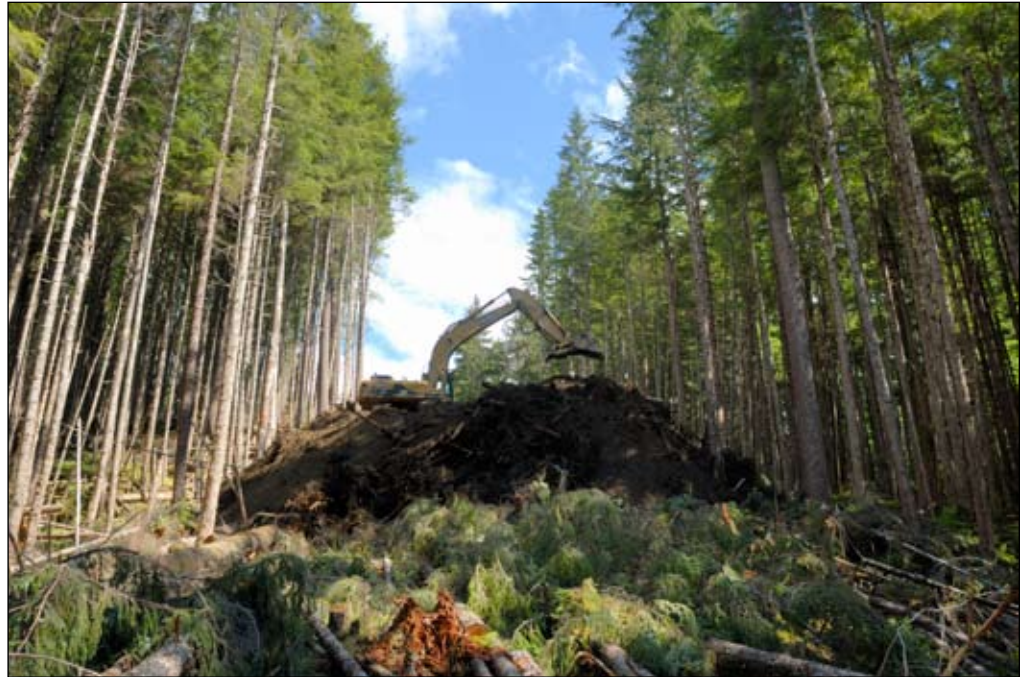
Large fill across steep section in the clearcut area.

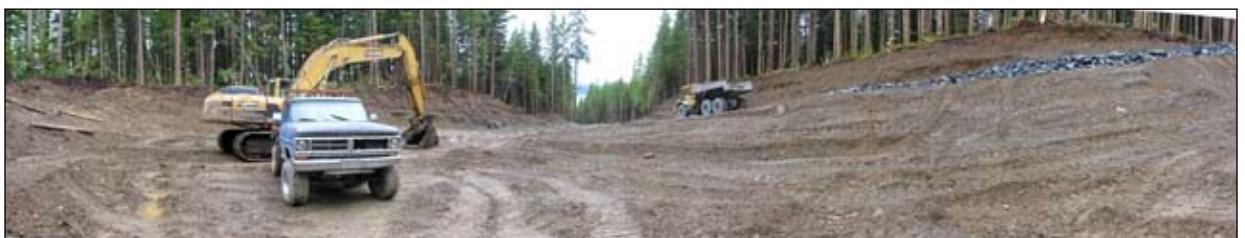
Pit #5 - Gravel source at the clearcut. Road/penstock alignment in back of photo.

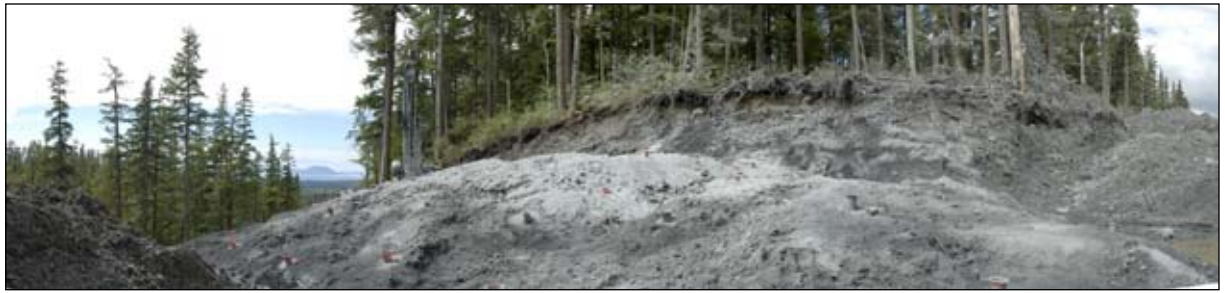
Blueberry hill - Pit #4 drilled and ready for the first shot. Note intact bank at left.

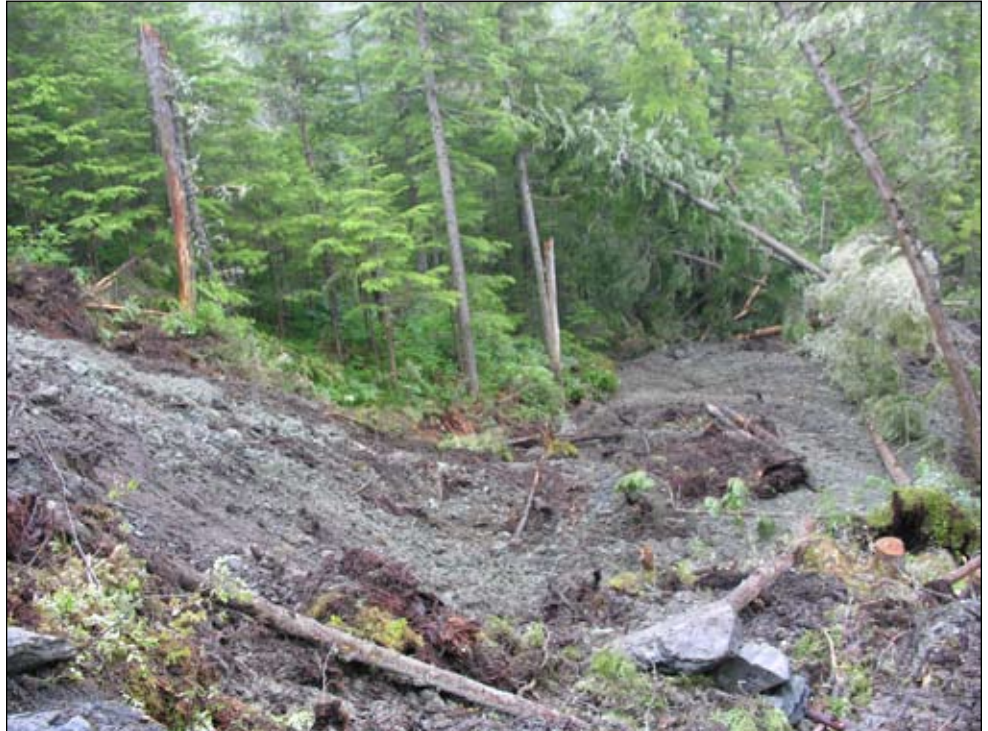
Initial cut/fill and stripping of the blueberry hill road cut resulted in a mass wasting event that raised concerns for protecting fish habitat in Falls creek. In consultation with the ECM, it was decided that no additional cut and fill work would take place on

Slide just below pit #4. Falls Creek canyon is ~ 50' beyond terminus.

A mass wasting event occurred as a consequence of stripping pit #4. The forested slope immediately below the area being stripped for blasting of the roadway alignment gave way and slid toward the Falls Creek canyon. The total area of this slide was approximately 15000 ft² and has settled with a terminus approximately 50 feet from the edge of the Falls Creek canyon. Though the material has drained some since the event it appears to be collecting and holding enough water to remain fairly soft and may continue to ooze toward the edge of the canyon. When the construction superintendent was asked about "shoring-up" the slide he advised against moving equipment into the area because the area is too unstable to support the weight of heavy machinery. During heavier rains the slide erodes and contributes sediment to the Falls Creek directly below the terminus. The total effect on measured turbidity has been nominal thus far. If the area should begin to contribute larger amounts of sediment to the stream it may be possible to create settling ponds with hand tools between the terminus of the slide and the canyon lip. Revegetation through hydro-seeding or other means is advised as soon as possible.

the approach to the blueberry hill road cut and a spoils area was selected just south of the strip fen Y that does not drain to the Falls Creek watershed and poses no threat to fish habitat. To lessen the chance of additional slides toward Falls creek, the road route was moved up-slope and developed as a trench cut rather than a bench cut. This left the slope on the canyon wall largely undisturbed. The July 19 shot resulted in no-mass wasting. See the attached Record of Concern (appendix 2) for more details.

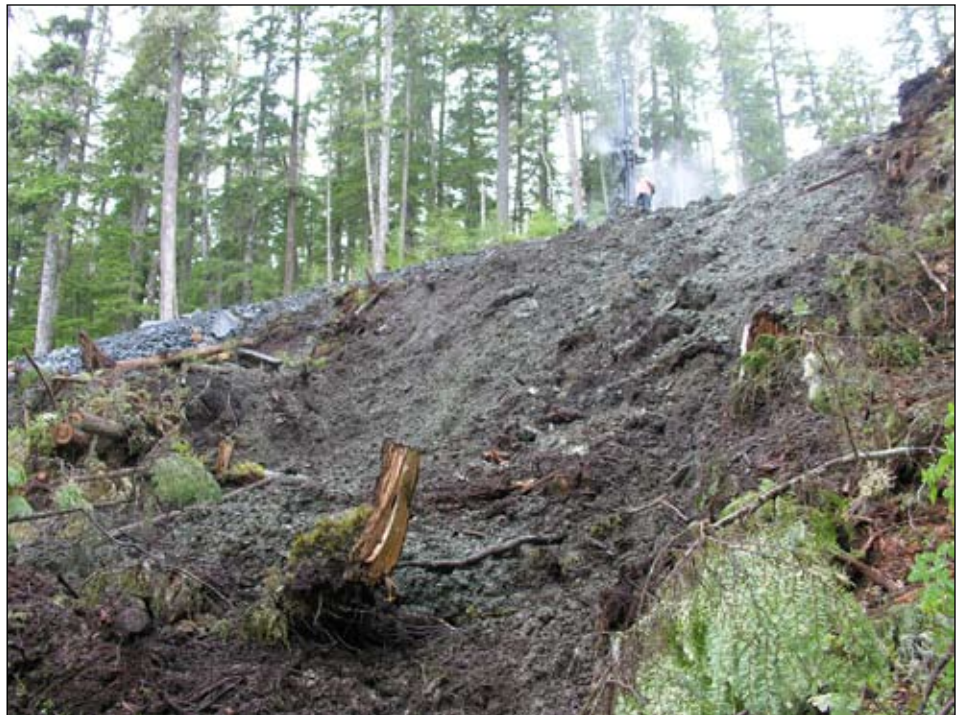
Looking up hill from mass wasting slide below pit #4.

The slide described above generated considerable concern for slope stability in the vicinity of the blueberry hill blasting area (pit #4). Although the project manager and construction superintendent immediately altered construction and blasting plans to account for a heightened awareness of slope instability, the ECM felt it

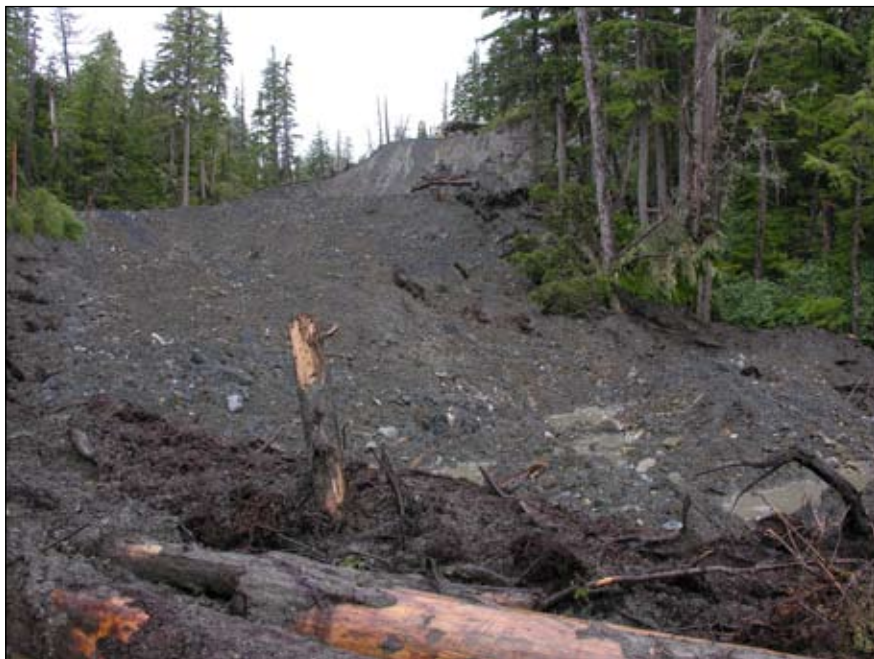
Consultation between the construction superintendent and the ECM resulted in the selection of the 4th major spoils area just south of the Strip Fen Y (see Figure 1). This area was selected in order to minimize impacts to rare wetland types, provide a slope for efficient backhauling and avoid sedimentation into the Falls Creek watershed. Deposition in this area has resulted in mass wasting as the terminal lobe lurches downhill after loading. Backhaul materials associated with construction of the intake site access road will be dumped here.

Spoils area near the Strip Fen Y. Site is currently 2 acres.

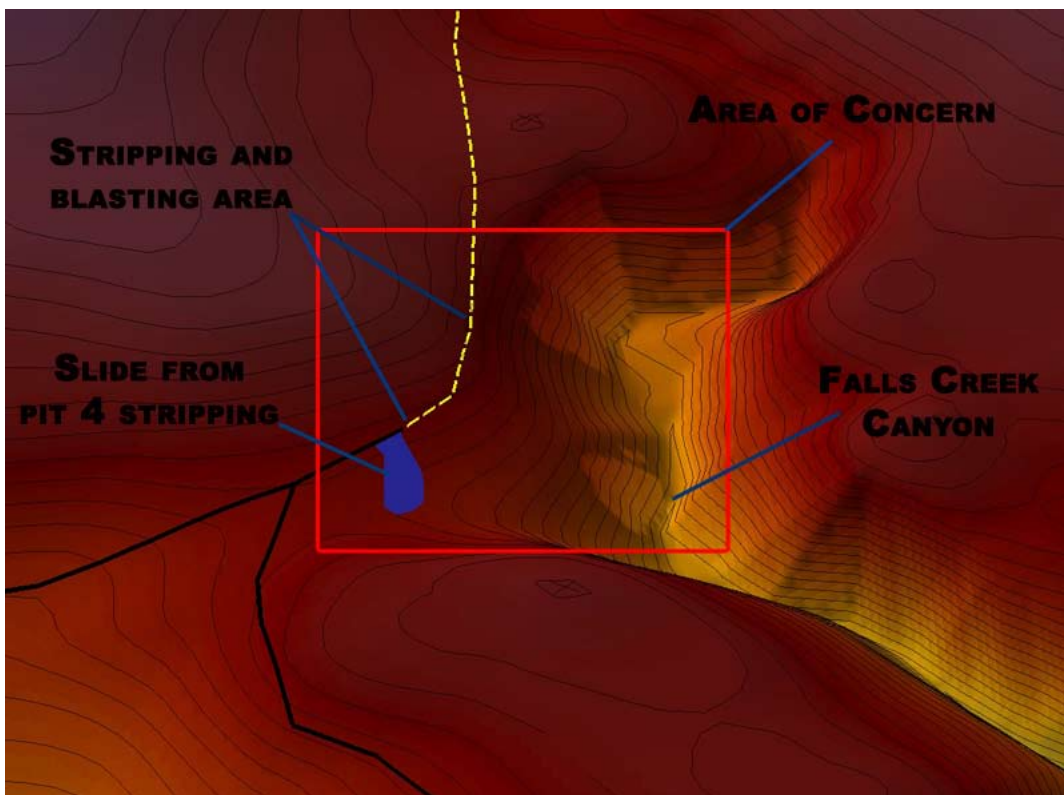
The slope immediately below pit #4 ranges from approximately 60-80%. Geotechnical work has not been done for the pit area or slope immediately below the pit so the depth of overburden and bedrock characteristics are largely unknown. Clearing and blasting of pit #4 may result in a large mass wasting event that would negatively impact fish habitat in Falls Creek.

Figure 2: 3 D model of concern area.

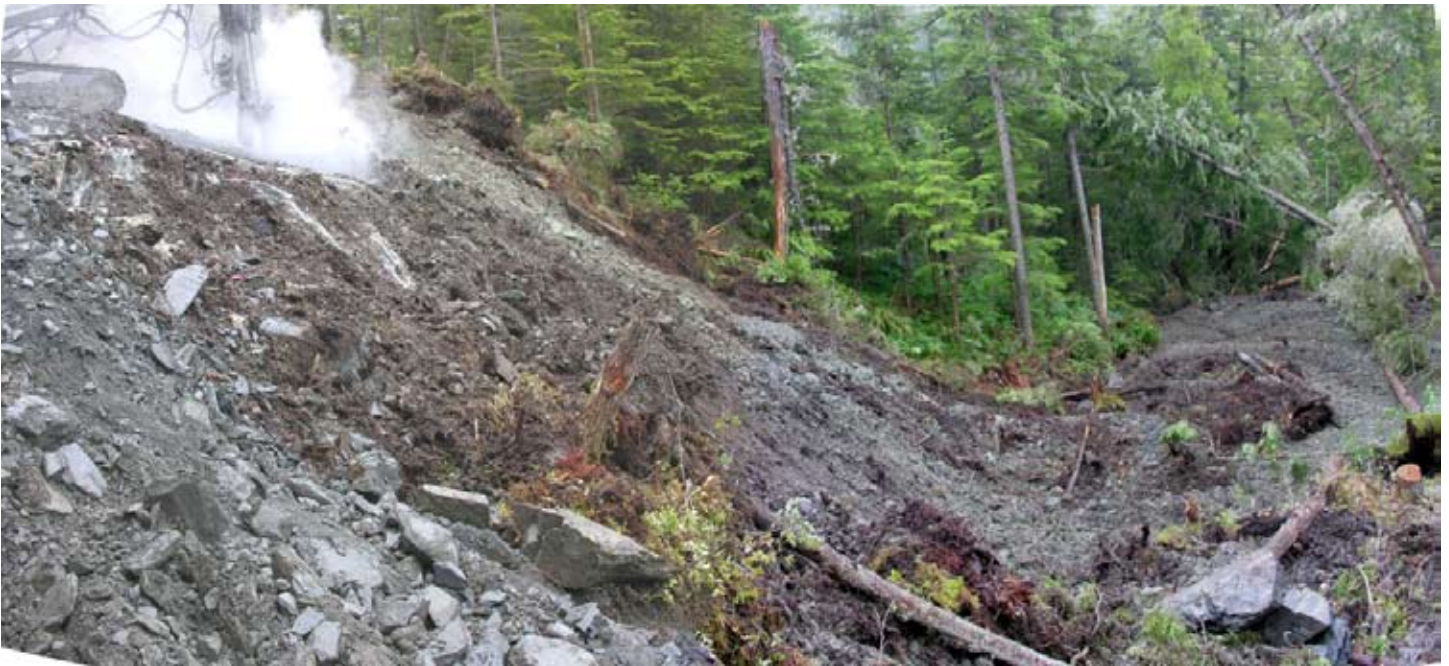
Initial removal of overburden in this area resulted in a slide of approximately 15,000 square feet (figures 3,4,5). This slide is poised approximately 50 feet from the Falls Creek canyon lip and may continue to move over the edge of the canyon or otherwise provide a source of sedimentation/increased turbidity in Falls Creek during heavy rains.

Figure 3: Slide below pit 4/road penstock-of-way stripping and drilling area. Toe of slide is approximately 50' from canyon lip.

We are doing everything we can to minimize the possibility of mass wasting in this area. The alignment of the road has been moved away from the canyon wall and a trench cut will be used rather than a bench cut - Thus minimizing the disturbance to the slope. After the slide event of last week no more overburden is being deposited on slopes leading to the falls creek canyon.

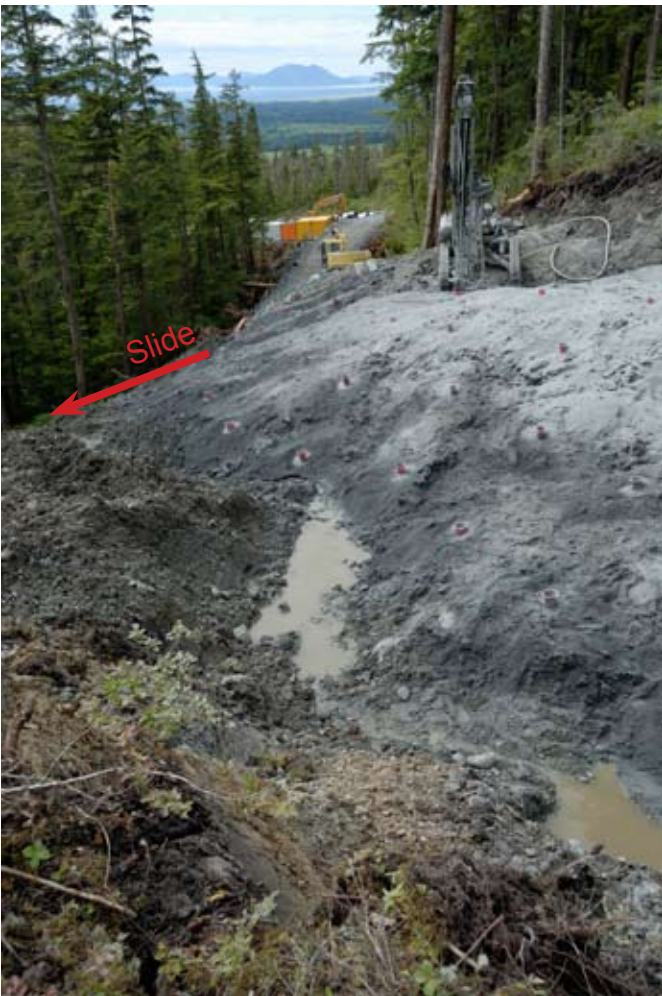
Figure 4: Looking southwest from pit 4. Steep slope is just behind photo location. Slide area off to left.

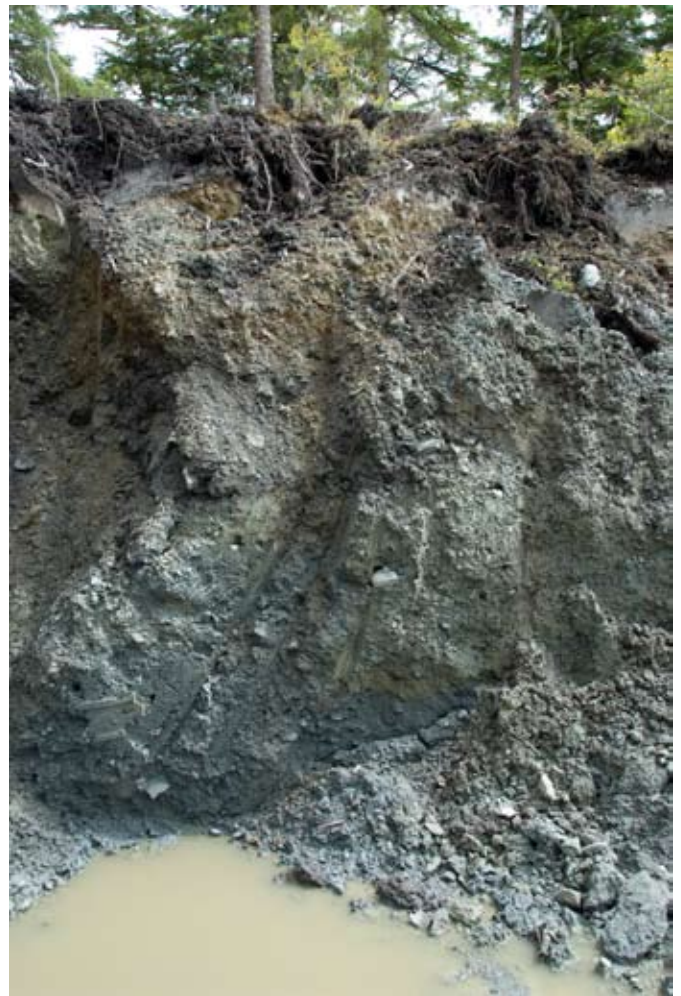
Figure 5: Looking at the profile of the 20' berm left on the downslope slide of the blasting area. Mix of clay, gravel and dirt.
